# The Dean Library Fact Sheet

General Motors Corporation

PD-4903 - PD-4905 - P8M-4905A - H8H-649

## **SAFETY ADVISORY**

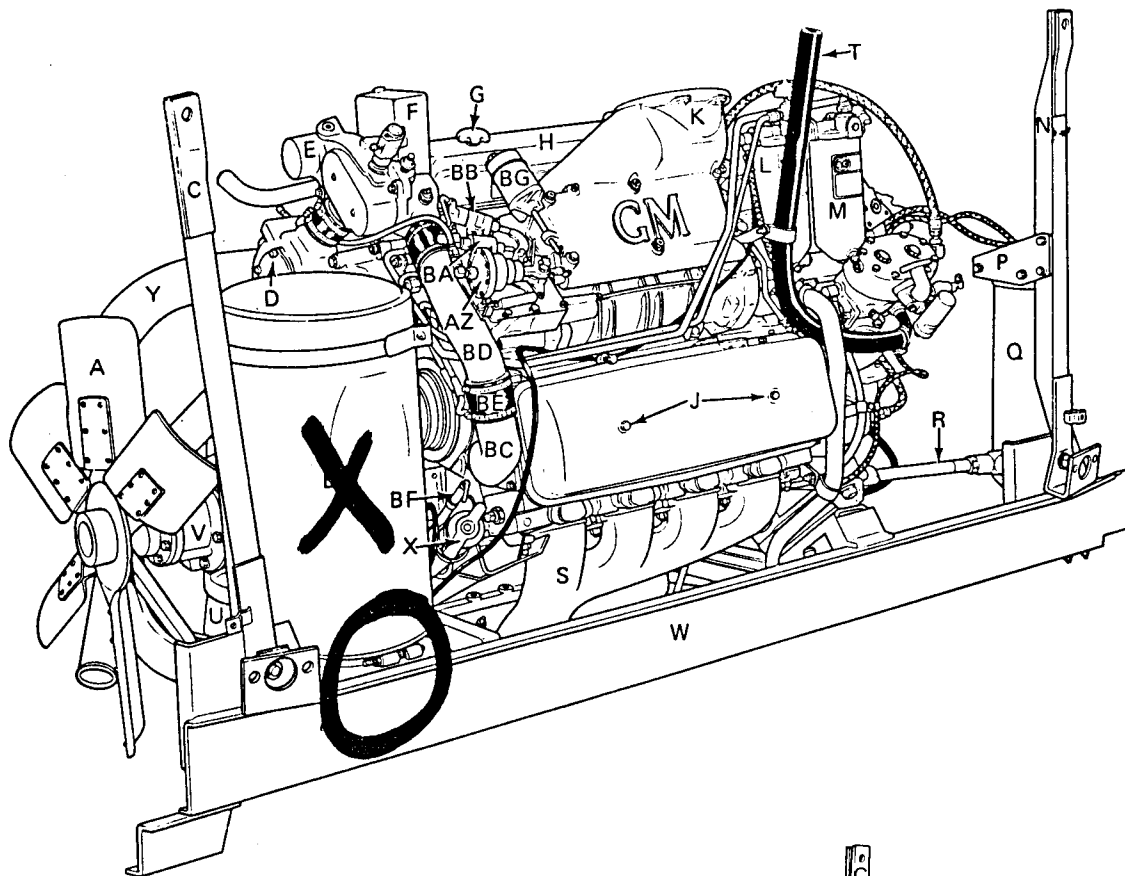
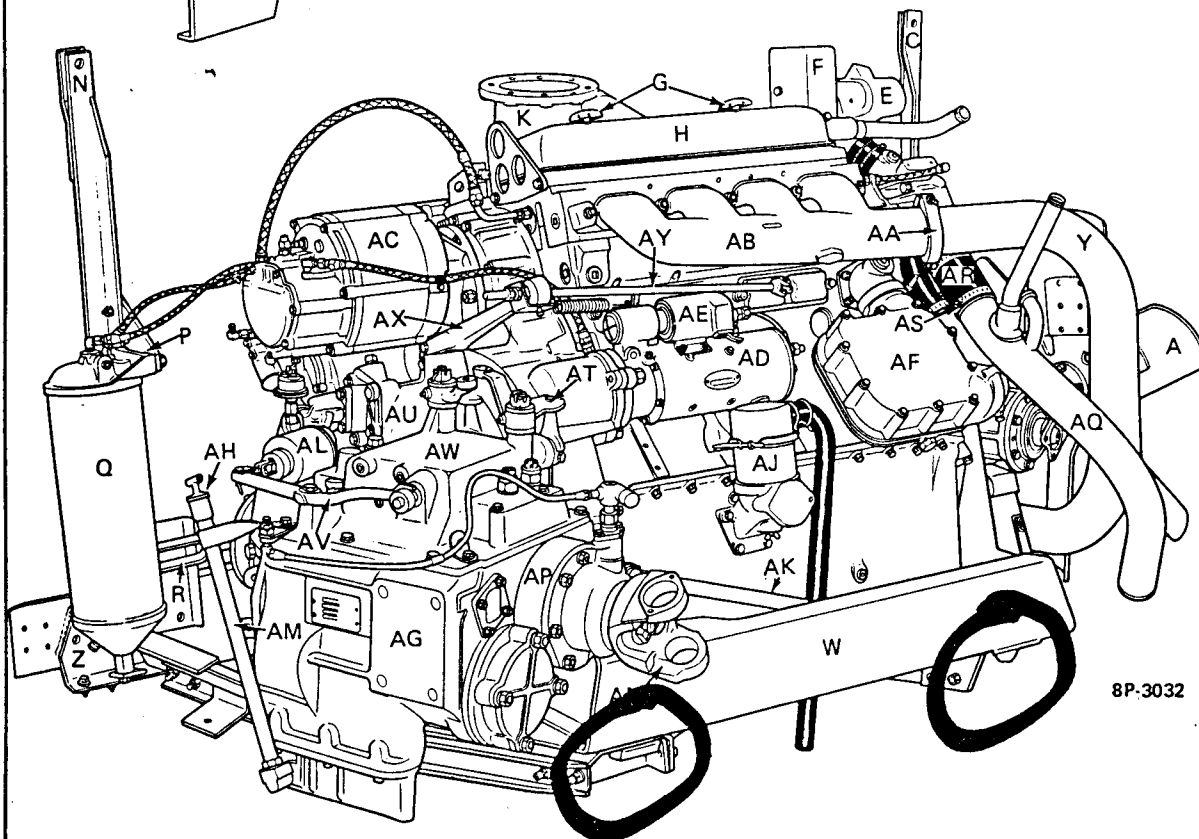
COMPLETE ENGINE W/MECH. TRANS. (8V-71)

Check all areas on the diagrams that follow which are marked with a X or O. These areas are critical for checks because of Corrosion, Cracks and Rust. These places that are marked are standard problem areas on GMC coaches.

The engine should always be the first area to examine when looking at any coach, for the engine can be the most expensive component to repair or replace in any coach. Some of the things that need to be checked concerning the engine are as follows.

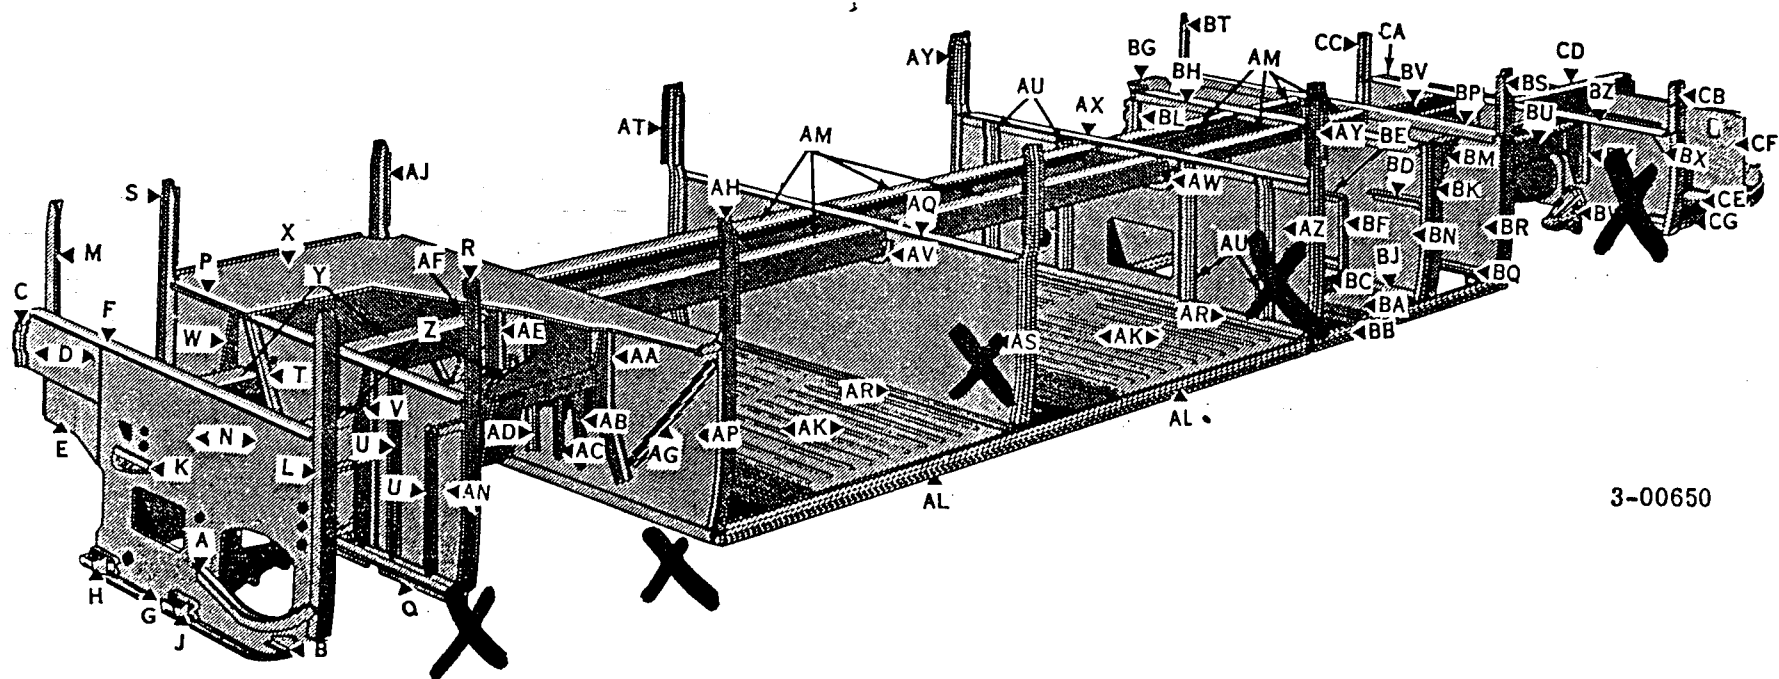
UNDERFRAMING (REAR VIEW)

1- This section will cover the areas in the body and frame that are prone to Cracks, Rust and Corrosion. It is very important to remember that the geographical area that the coach has been operated in as a direct effect on the amount of Rust and Corrosion that may be found on the coach. A quick way to determine if there is rust behind the skins on a coach is to sight down parallel with the body of the coach. If in sighting down the body of the coach and there appears to be any Bulges in the skins, this could be a indication that there is rust built up behind the skins causing them bulge. Also look closely for a group of body rivets that are loose for this could also indicate that rust has built up behind the skins, (Body Panels) causing the rivets to pull loose. Check all areas on the diagrams that follow which are marked with a X or O for Rust, Cracks and Corrosion.

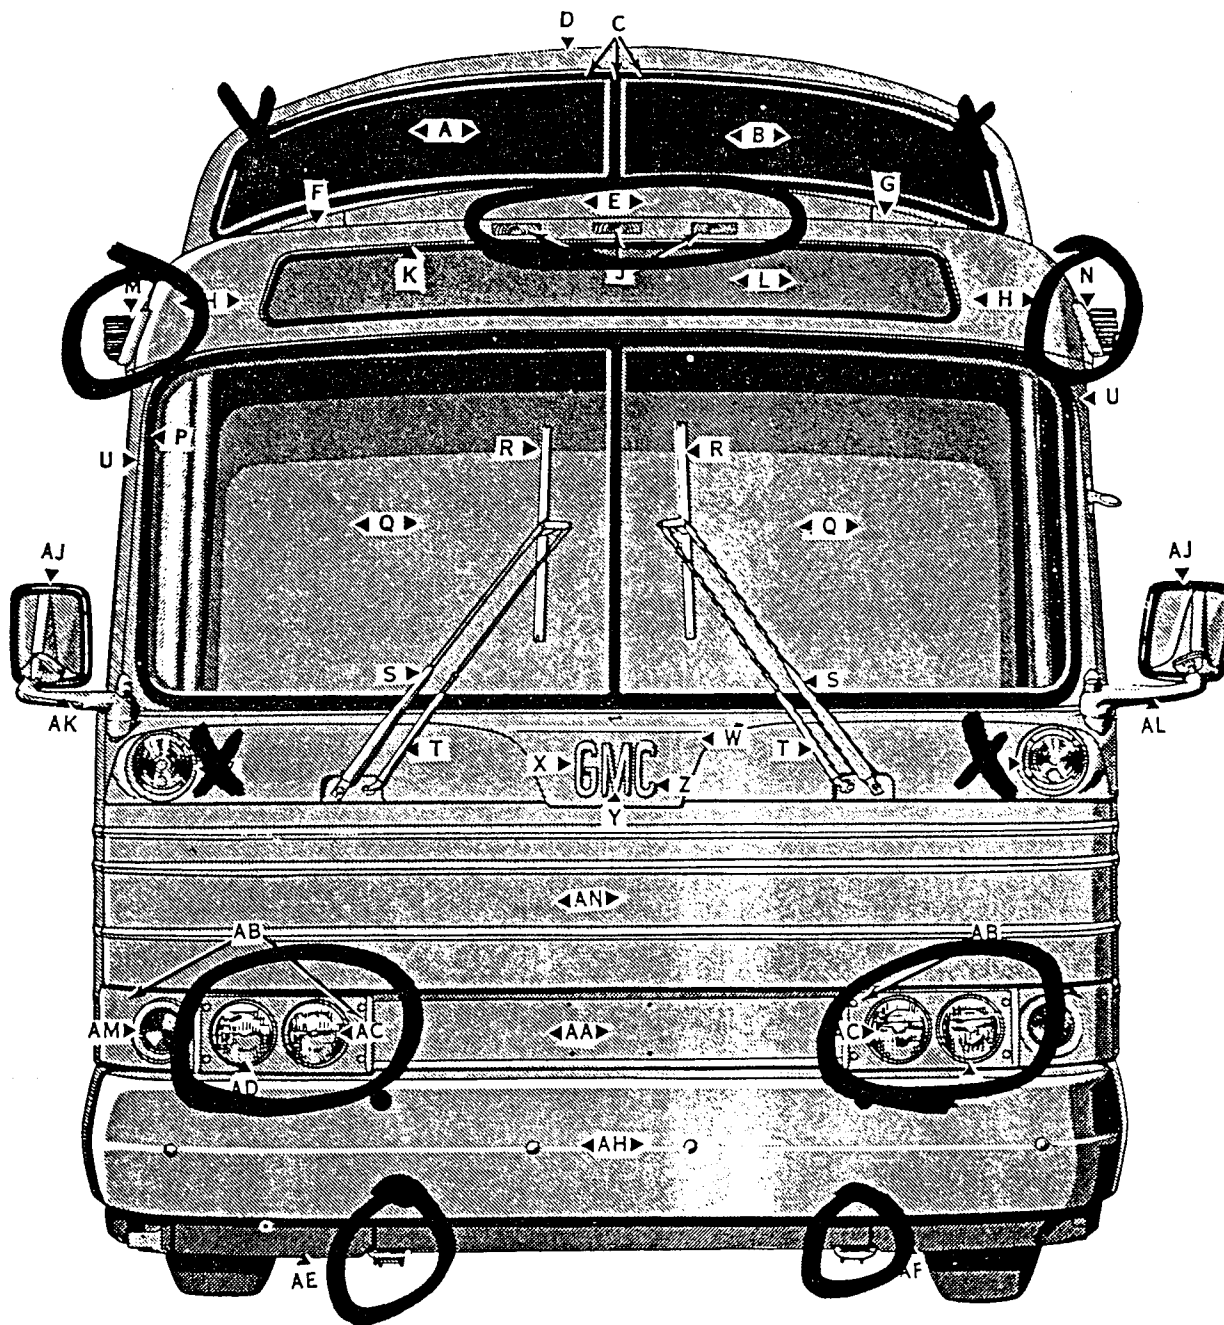
### FRONT END OUTSIDE VIEW

Check around all windows for Rust  
and also for leaks. Check window seals.

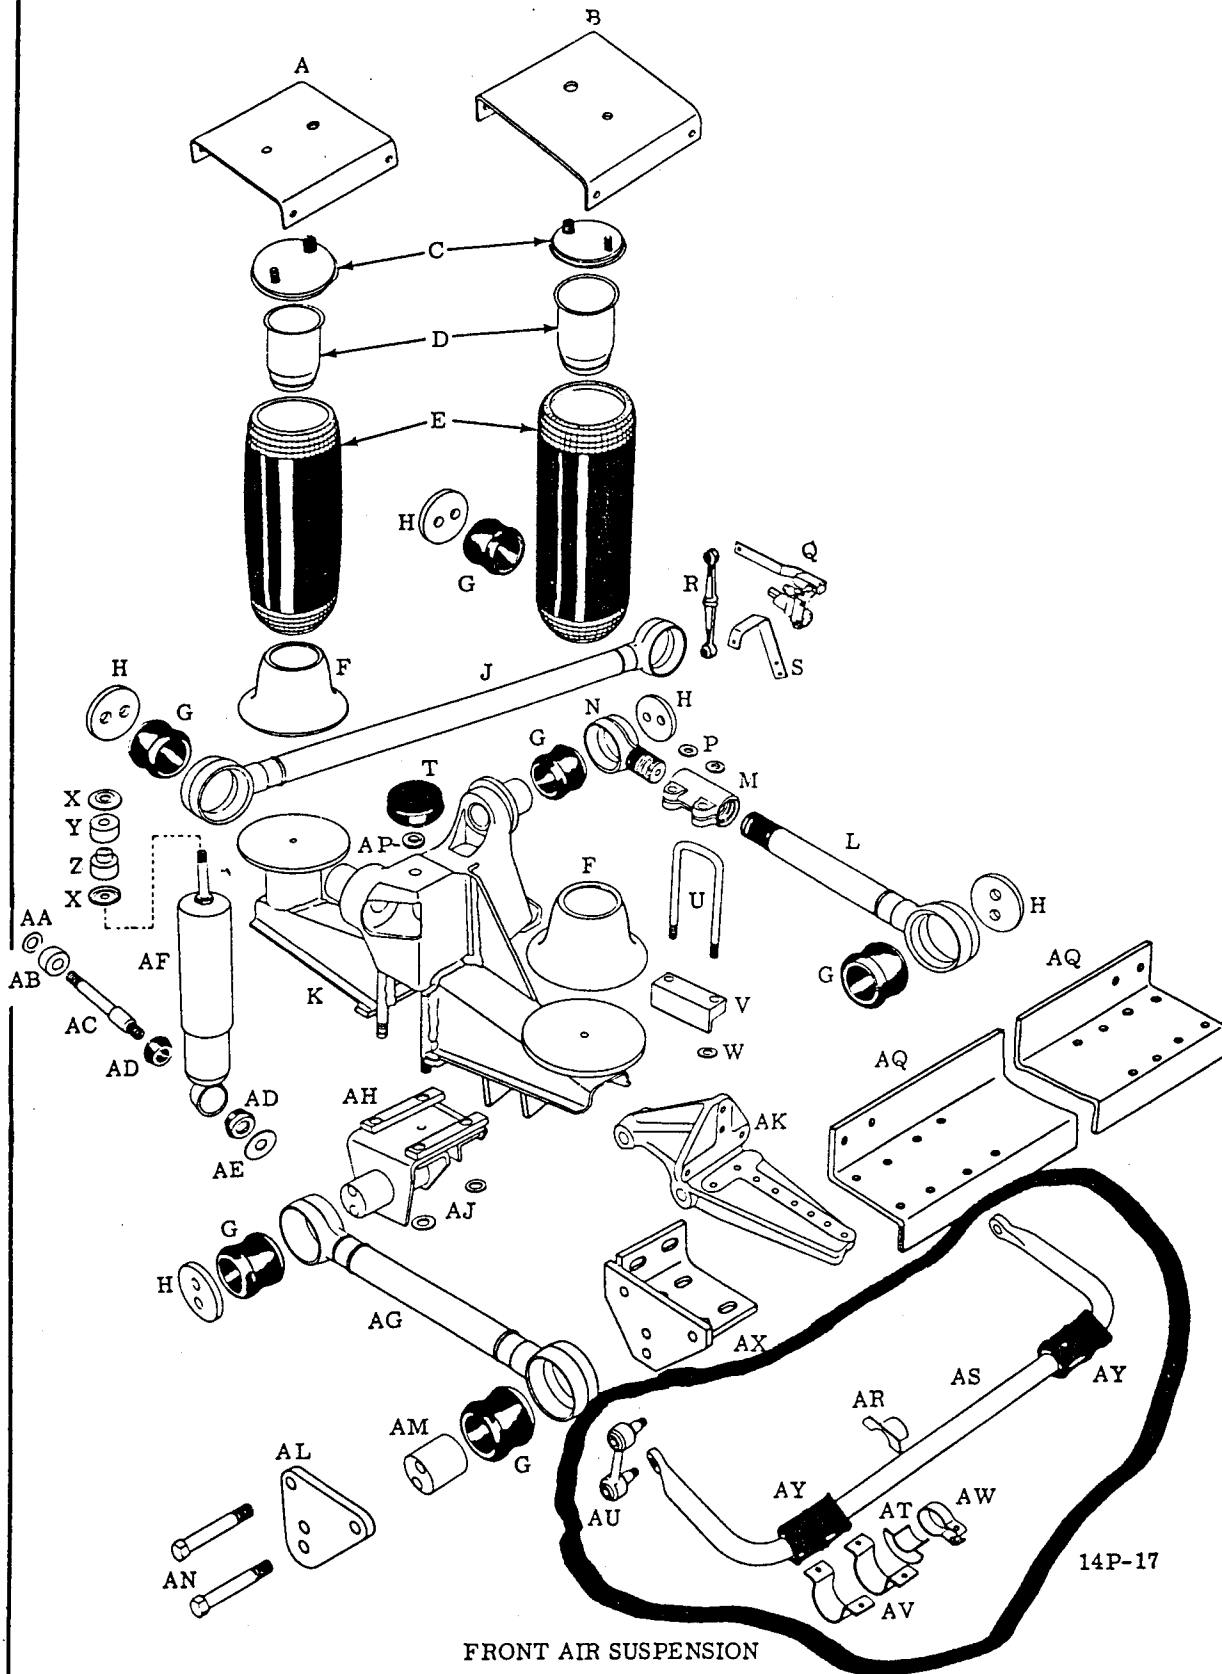
FRONT AIR SUSPENSION

**Radius Arms;** which are circled in the following diagrams. The radius arms have rubber bushing inside the round section at each end. The rubber bushing should appear intact and pliable. Also note any shiny areas on the metal housing where the bushing are installed. A wide shiny area of more than 1/4" can indicate worn bushings causing excessive movement of the front or rear axle. The rubber bushings are not very expensive, however the labor required to replace these bushing's can be rather high. Remember that there are radius arms on the top and bottom of the front and rear axles.

**Air Bags;** which are marked with a X in the following diagrams. Check the air bags for Dry Rot, Cracks and Bulges. Check the steel top mounting plates for excessive Rust or Cracks. Check the bottom mounting cones for Cracks and also for excessive Rust underneath. One sure way to check for leaks in the air bag system is to start coach, let the air bags fill to maximum air pressure. Shut engine down and watch coach for period of time to see if coach starts to lower on one side. Some air leaks in the air bag system is fairly common in coaches, however a coach with a properly maintained air suspension system should remain level for quiet a long period of time,(the longer the better).

**Stabilizer Bar;** which is circled on the front air suspension break-down diagram only,(not shown in rear). Some models do not have stabilizer bars however most do and need to be checked. These bars are connected to the front and rear axles with Bar Links,(AU on diagram). Check these links for distortion in rubber around mounting studs. The stabilizer bar is attached to body of coach with rubber bushings and U-shaped clamps. Check rubber bushings for Dry Rot and excessive wear. The stabilizer system works to prevent excessive swaying of coach body.

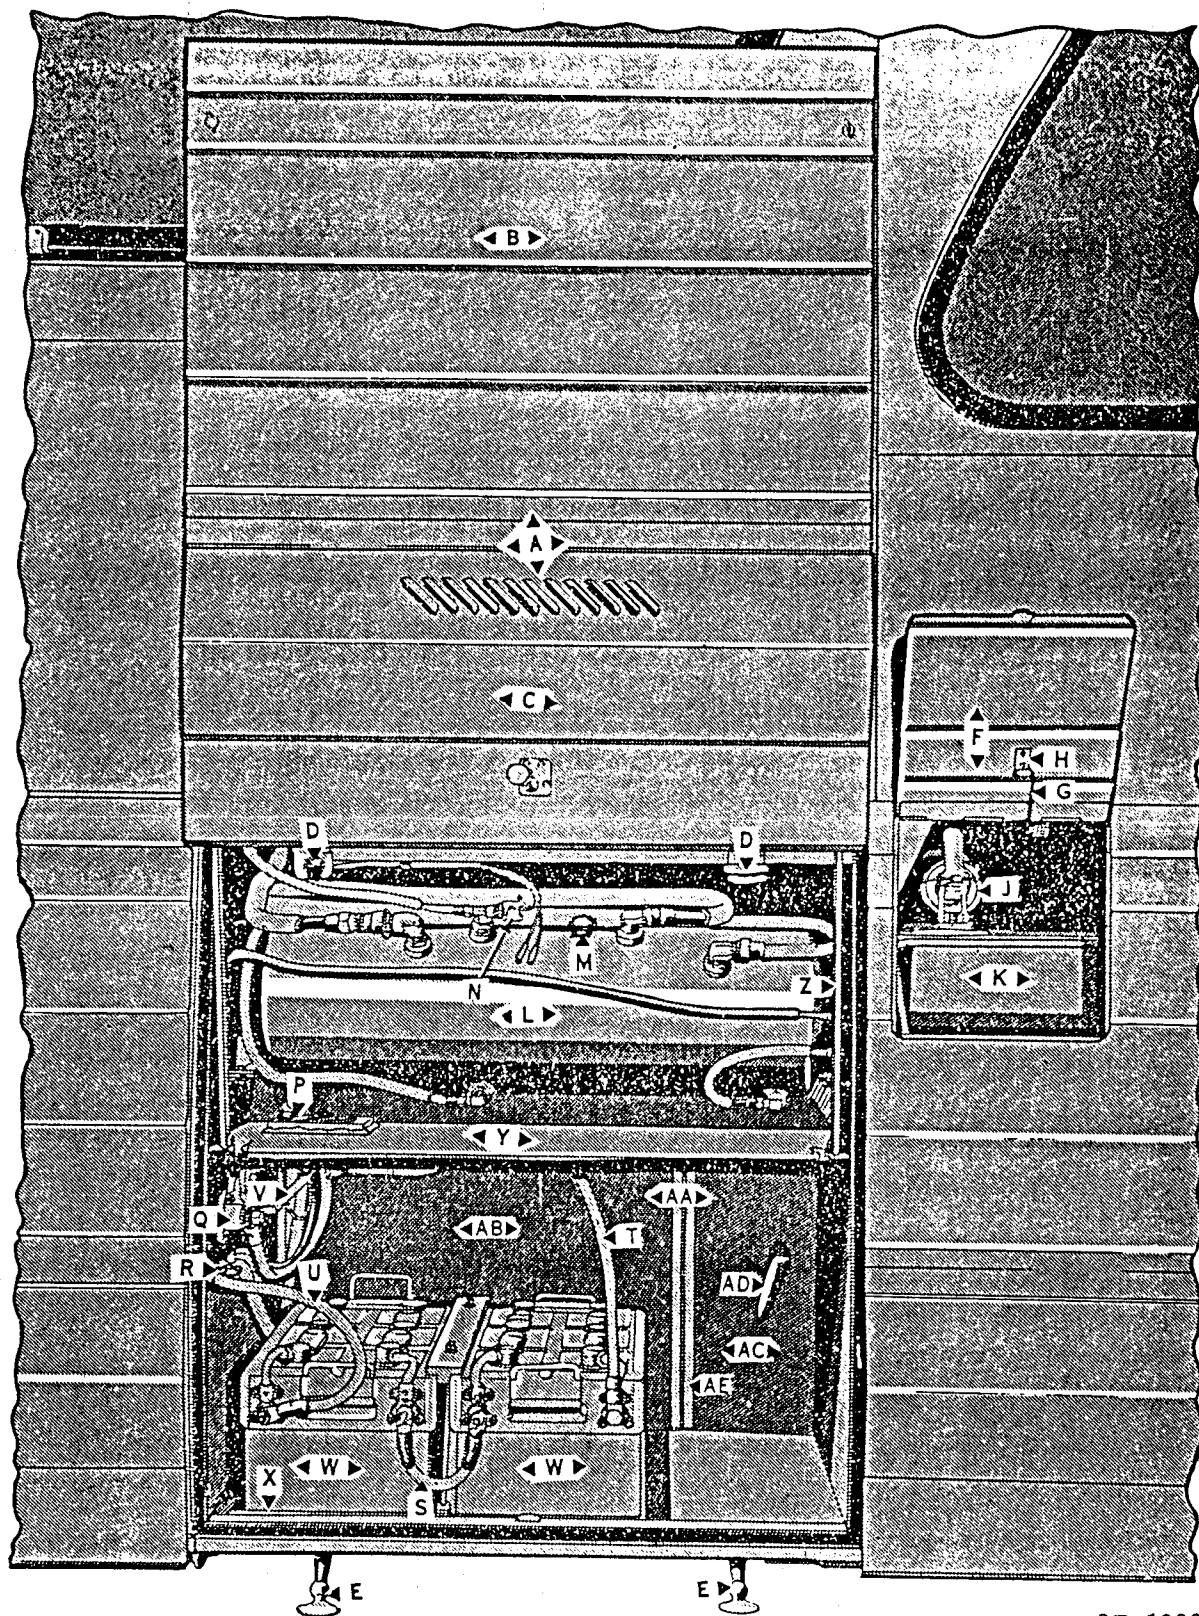
EVAPORATOR AND BATTERY COMPARTMENT  
(W/DOOR)

**Air System:** It is always a good idea to check the air system for oil contamination and also for a excessive amount of water in the air tanks. This is easily done by building up some air pressure and then opening a drain cock on one of the wet tanks on the coach. On the diagram marked Evaporator and Battery Compartment notice that there are air tanks located at the top of this compartment. Inside the small door that is also open in diagram,(Fuel Fill Door) on the left hand side there will be a drain cock. Open drain cock and check for oil contamination mixed with the escaping air. Excessive oil in the air system can indicate a worn air compressor. An excessive amount of oil in the system can cause problems with Rubber O-Rings and Diaphragms used in most all the air system components. Some water can be expected in when opening drain cock, however a coach that is properly maintained would have it's air tanks drained often, so a lot of water could indicate a poorly maintained coach.
